# Case Study

## **Schöck Isokorb matches perfect Velux Headquarters building**

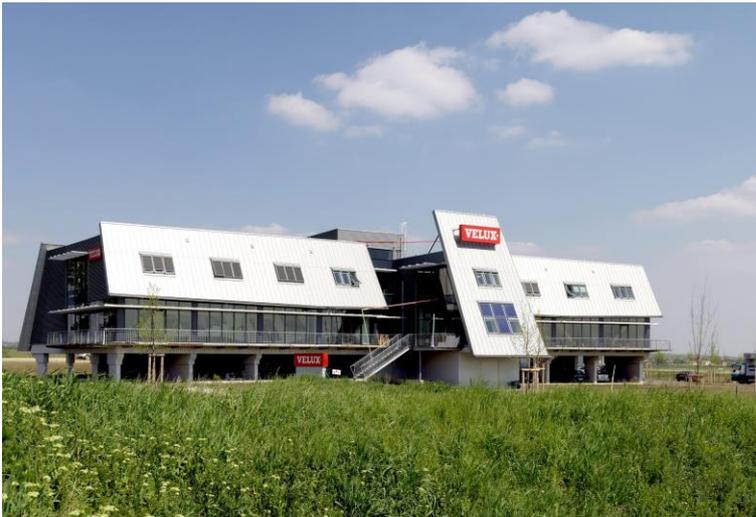
[VeluxHuger4.jpg]

*The unusual sloping roofs stand out immediately.*

Designed by architect Werner Zita, it is a building in stark contrast to what has been there before and draws on the local ambition to introduce more modern architectural styles to this otherwise traditional wine district area of Lower Austria. The unusual sloping roof stand out immediately and as Zita explains: “The linear layout of the building does not conform to any conventional right angles and is an attempt to reflect the undulating local landscape”.

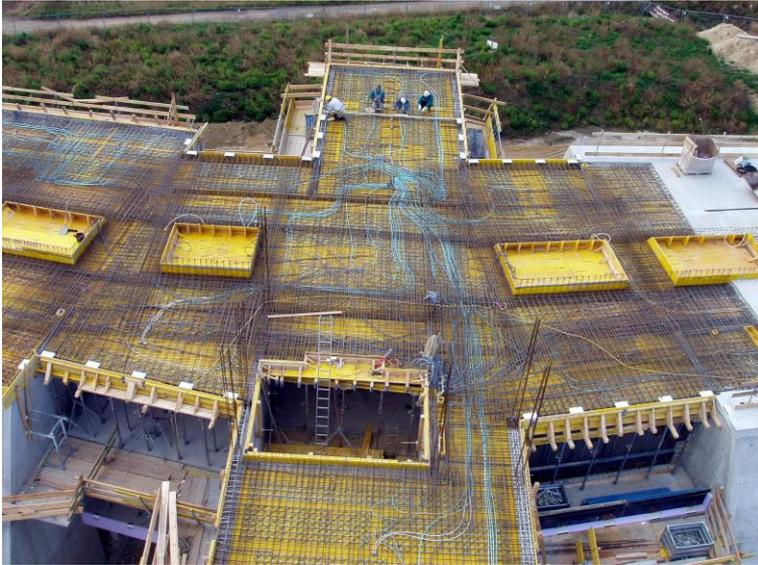
**[VeluxZita2.jpg]**

*Early site work at the Velux Headquarters.*

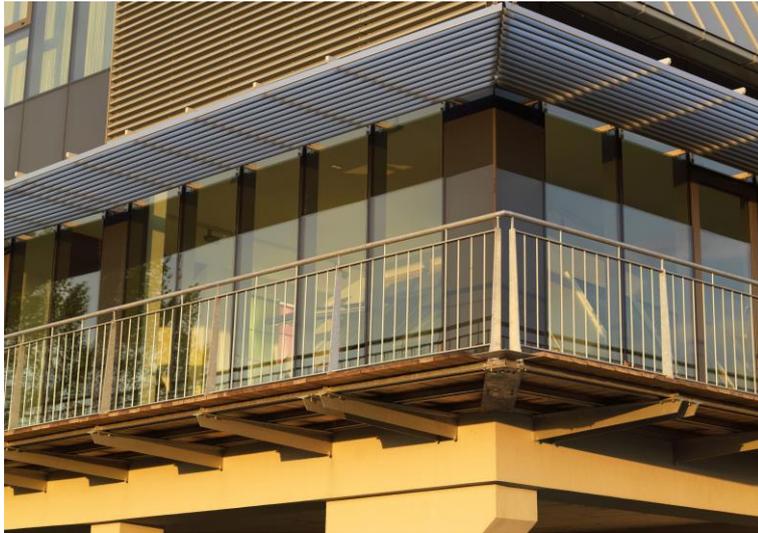
[VeluxHuger3.jpg]

*Balconies around the perimeter of the building.*

The facade and roof are made from a titanium zinc outer shell and the varying textures are achieved through the use of longitudinal sectioning. An angled standing seam technique is used in the steep roof areas, with a horizontal open slat facade in the entrance areas and on vertical surfaces. Balconies are widely incorporated around the perimeter of the new Velux building and the prevention of thermal bridging was an early design consideration. It is critical to do so because the resultant heat and energy loss are only two of the consequences if thermal bridging should occur. Condensation and mould growth can develop as well, which may lead to potential health and respiratory problems for the occupants. So with balconies around the building connected to the edge of the internal reinforced concrete slab, preventing the possibility of thermal bridging at these connectivity points is crucial.

For this particular application the Isokorb type KS from Schöck was the ideal solution. It is a concrete-to-steel thermal break module that sits between the outer and inner structural connection points and

reduces the loss of energy through the use of high quality EPS insulation. The Isokorb thereby enables a thermally insulated, load bearing connection to be made between reinforced concrete and steel construction components, and at the same time provides a clean and unobtrusive connection detail.
